**NOTICE OF NONCOMPLIANCE
OR
NOTICE OF NONCOMPLIANCE
& PLAN OF CORRECTION**

Hogan Dairy Farms

CONFINED ANIMAL FEEDING OPERATION (CAFO)

WQA
 NON
 NON/POC
 INSPECTION FORM

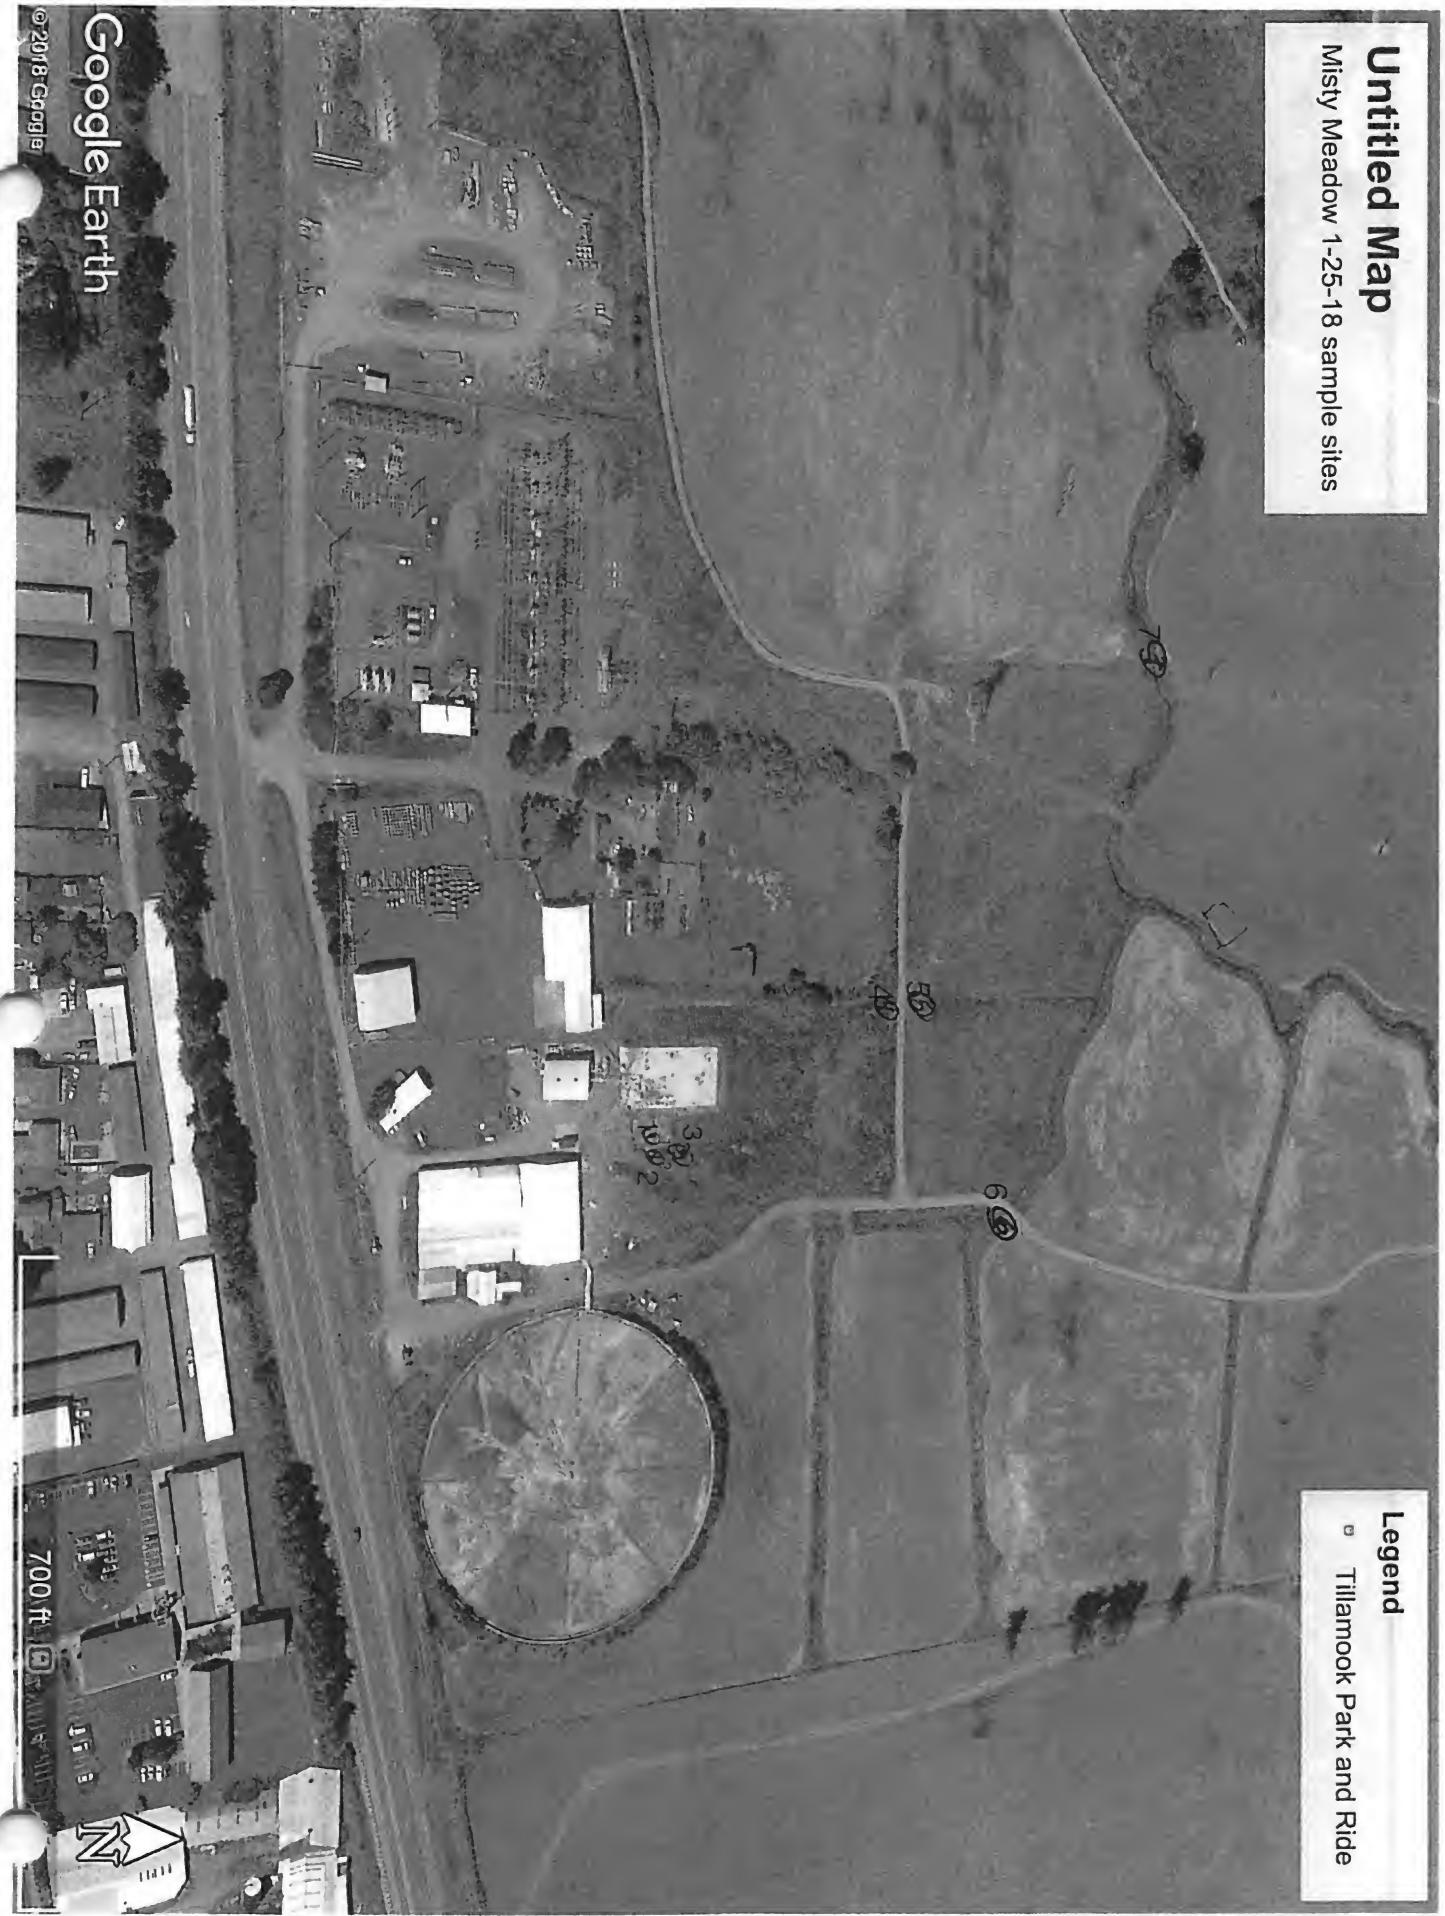
Misty Meadow 1-25-18 sample sites

- Collected Samples from area on North side of digester. Effluent containment pond is full. On December 3rd pump plugged resulting in digested material flowing to effluent containment pond and into field. 7 samples collected!

Sample #1 - from digester

2 - Adjacent to digester

3 - down hill from digester

4 - South side of Cow Lane culvert in ditch

5 - North side of Cow Lane in ditch next to Culvert

6 - Up stream

7 - Down stream
